# **Appendix D**

## **Anomaly, Failure and Mishap Reporting**

## D.2 Significant Events

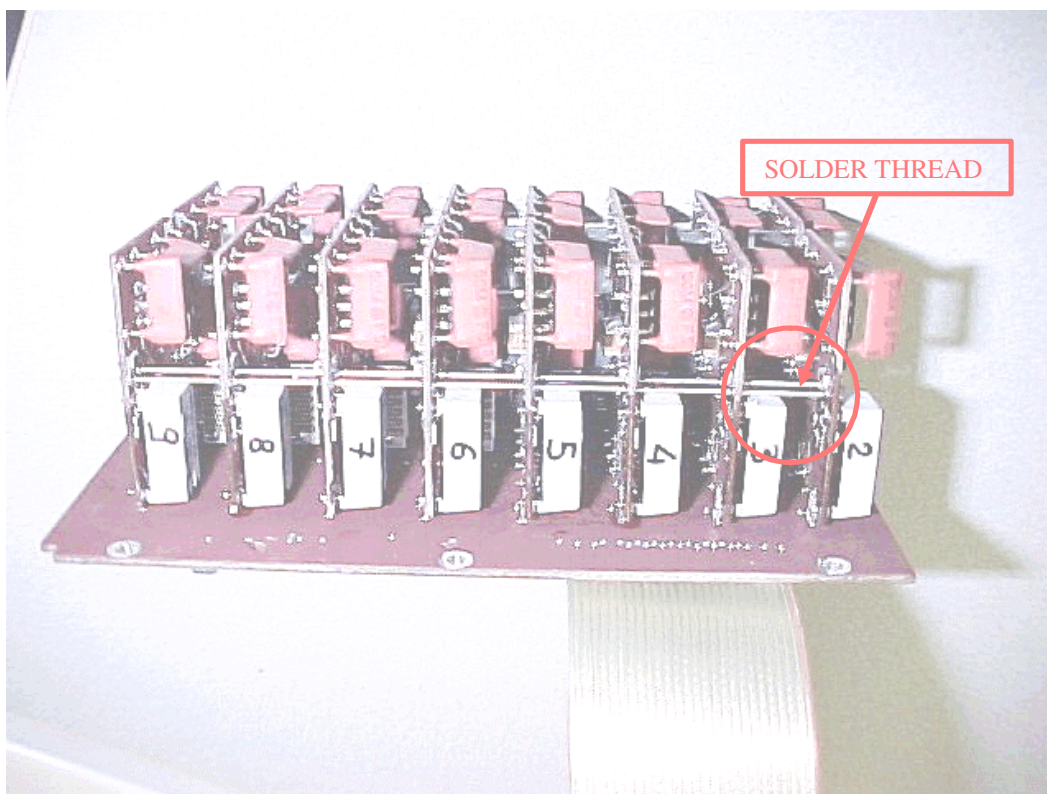
Picture 1 – side view of TOF Linear Regulator.

The *Linear Regulator* consists of a main board, with approximate dimensions  $5 \times 20 \text{ cm}^2$ , on which 16 *mini boards*, actually performing the HV regulation for each channel, are soldered in the vertical position (see picture 1). The soldering is done through *fork pins* which are shown in figure 2.

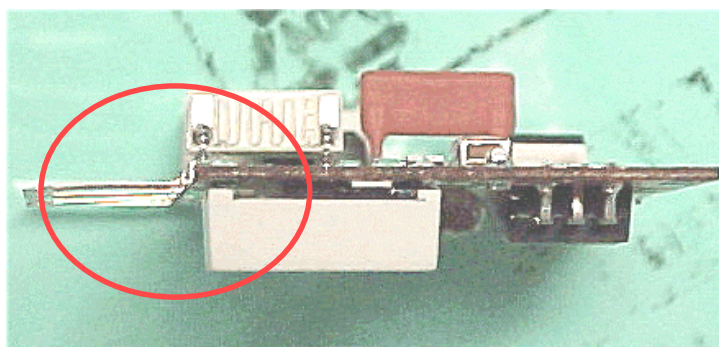
Picture 2 – View of the single regulator mini board with closeup of the straight pins used for the soldering of this component with the Linear Regulator main board.

To investigate the problem, the TOF *brick* was dismantled and the Linear Regulators were carefully inspected. As a result, some of the SMD soldering of the straight pins were found to be broken, as shown in figure 3. According to CAEN, the failures were due to different thermal coefficient between resin and soldering material, generating a stress able to cause the connection rupture.

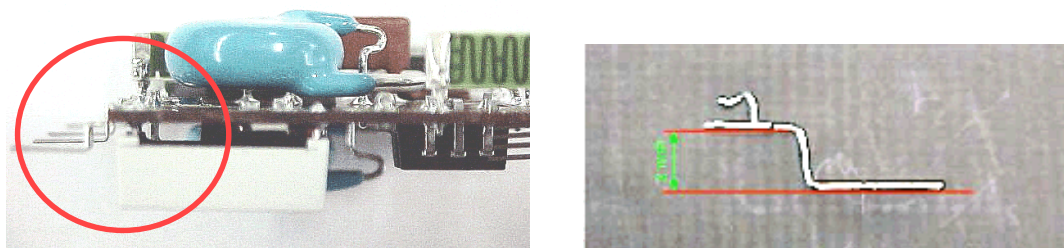
Figure 11 – New mini board with preformed pins(left). New shape of *fork pins* (right).

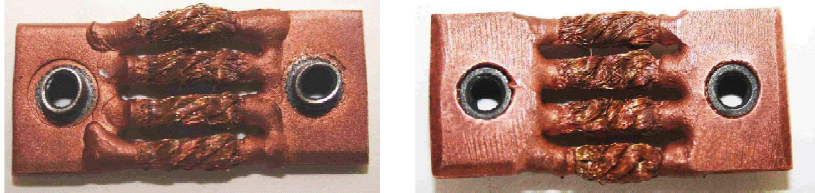
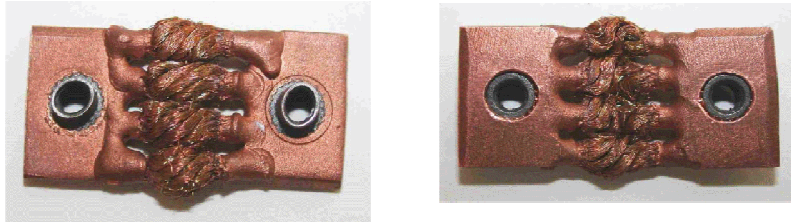
### **Appendix A: Thermal connector compression, damages**

Compression along Z-axis is applied to the braids in order to restore flexibility and to adjust the length in Z. Pictures below show a connector after compression.

This compression was performed *in situ* during assembly of the 3 planes of the inner tracker but before the definitive connexion. Some braids were damaged:

- Some weakness of the metal properties might have been introduced by the welding of the Copper braids
- The effect on thermal conductivity is negligible.
- The damaged threads showed a single break.
- No one was found to be loose.

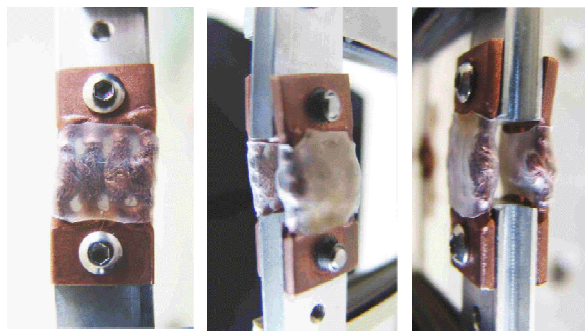
## **Appendix B: Containment of Copper braids**

We studied the use of Kynar heat shrink tubing (space qualified) to enclose the Copper braids. Preliminary tests on prototypes are shown below:

A procedure was established and was applied on all thermal connectors. A preliminary cleaning was made with a micro vacuum cleaner. The filter was examined. No broken thread was found in the filter.

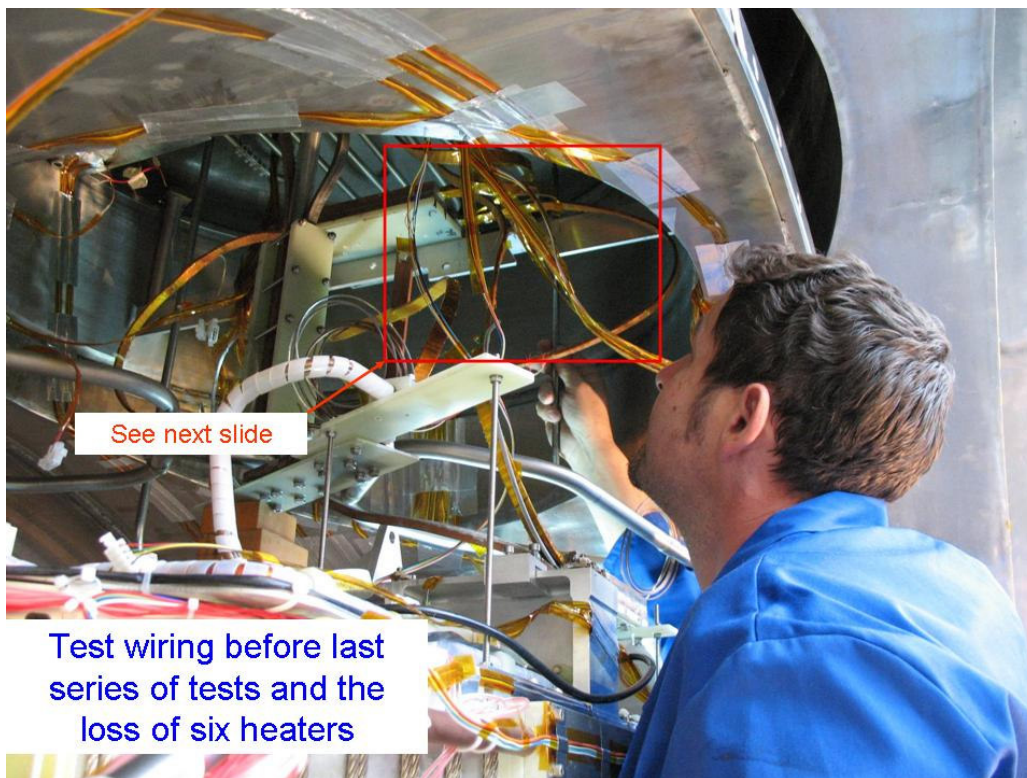
Figure 1: Test Wiring Before Magnet Testing

**Description of Event:** Prior to completing the assembly of the AMS Superconducting magnet, the magnet assembly was tested in a Magnet Assembly Test Rig. During this testing, several Special Test Equipment heaters were added to the magnet. These heaters were used to intentionally induce a quench in the magnet coils. Essentially, they were put in place to mimic the flight quench protection heaters or a random quench. The wiring for these heaters, which was also STE, was not adequately held in place to prevent movement during a quench. Essentially, the wires were bundled together with Kapton tape only (Figures 1 and 2). At the operating temperature of 1.8 Kelvin, the adhesive on the Kapton tape was not adequate to hold the wires together. During a magnet quench several of the wires experienced loads induced by the rapidly changing magnetic fields. These loads moved and pulled some of these wires out of the STE circuit board or the heater (Figure 3). The result of this was that several of the test necessary heaters to ensure no damage is done to the magnet were not functioning and the test had to be abandoned.

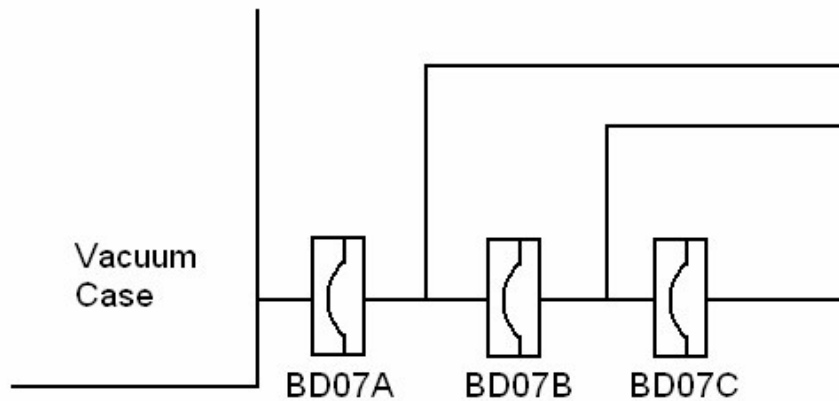
Figure 1: Vacuum Case Burst Disk Schematic

Originally, the system was designed with a single burst disk, which is typical for most high-performance cryogenic systems. At the Phase 0/I Flight Safety Review, the panel identified a new failure mode for the system. If the disk were to leak or spontaneously rupture within the atmosphere, air could enter the dewar's vacuum space. This would lead to a massive influx of heat into the tank of superfluid helium inside, which would cause it to rapidly warm up. As the helium begins boiling, the tank pressure would eventually rise to the burst pressure of the tank's burst disks and begin venting. If this were to occur during the point of maximum load during ascent, the Shuttle payload bay could be overpressurized. The panel therefore demanded a triple-redundant burst disk design to provide two additional levels of control against leakage. This arrangement is shown in Figure 1.

In the overall design, the original burst disk was called BD07, so in the new design, the disks were named BD07A, BD07B, and BD07C. Because the disks have a design burst pressure less than atmospheric pressure, vent lines have to be added to the interspaces between the individual disks to allow the air sealed in the tubes during manufacturing to escape. Otherwise, disk B and C would rupture when the outside atmosphere during ascent reached 0.2 bar. Given the small air volumes behind the disk, this would almost certainly lead to an incomplete rupture, which would prevent the assembly from providing the required overpressure protection. In Figure 1, these vent lines are shown as rising 90-degree bends from the interspaces.

This may seem to remove one level of safety control in the design, but in fact it has no bearing on the risk of leakage through the assembly discussed in the previous section. As shown in Figure 1, there was always a potential leak path through the vent tube in the BD07A/B interspace if a leak were to develop in BD07A. This potential leakage has already been assessed against the maximum credible leak used in the overall VC design and found to be encompassed by the existing analysis. In the new system, the potential leak path is through BD07B instead of BD07A, but this has no bearing on either the safety acceptance rationale in the overall safety analysis or on our compliance with it.

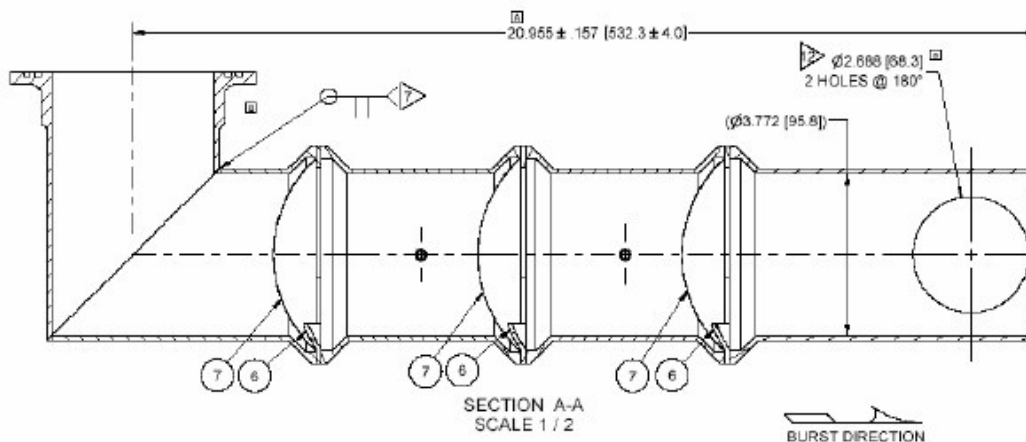
Figure 2: Burst Disk Assembly Design

The triple disk assembly was designed and manufactured by the Fike Corporation based on the schematic in Figure 1. The main vent channel has a large flange with redundant O-ring seals where the assembly bolts to a port in the VC. Figure 2 shows a section through the assembly. The small holes in the interspaces are the 0.25" OD vent lines, while the two 2.688" through holes are the zero-thrust vents for the exhaust.

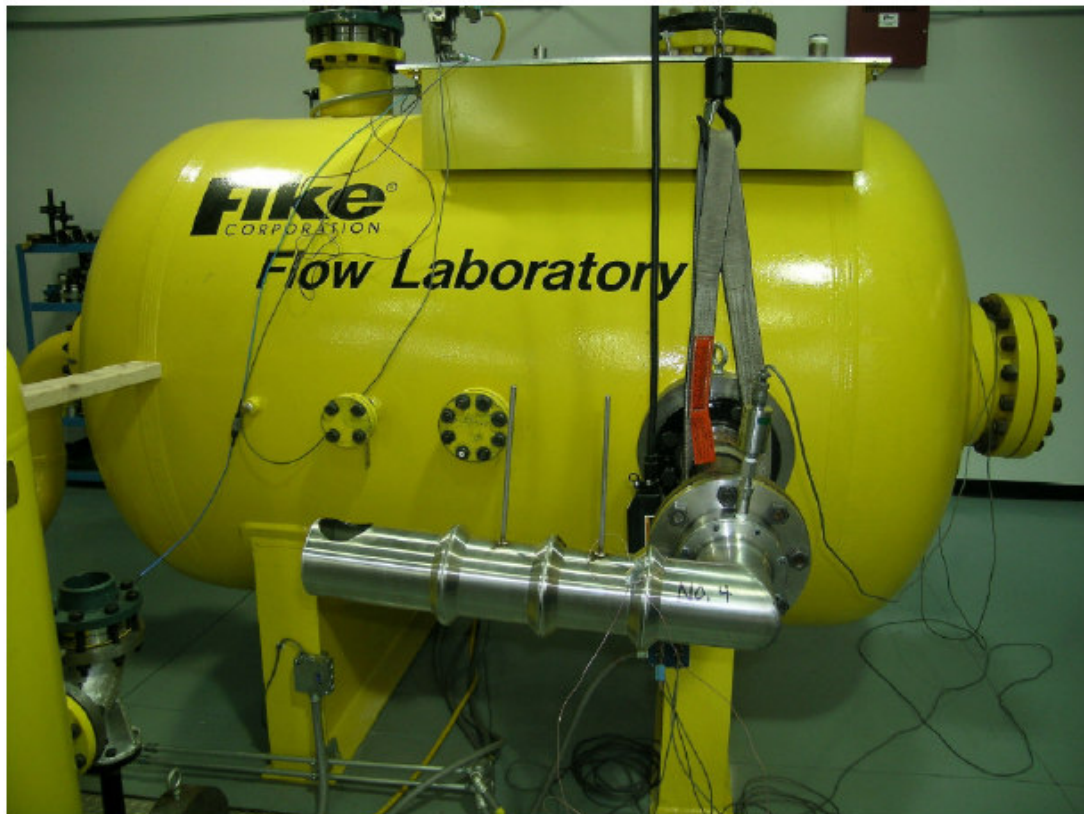
**Figure 3: Qualification Test Setup**

For qualification testing, each test unit was attached to a large pressure vessel filled with gaseous helium. Pressure in the space behind BD07 was allowed to rise slowly to the design burst pressure, at which point all three disks should have burst. The setup is shown in Figure 3.

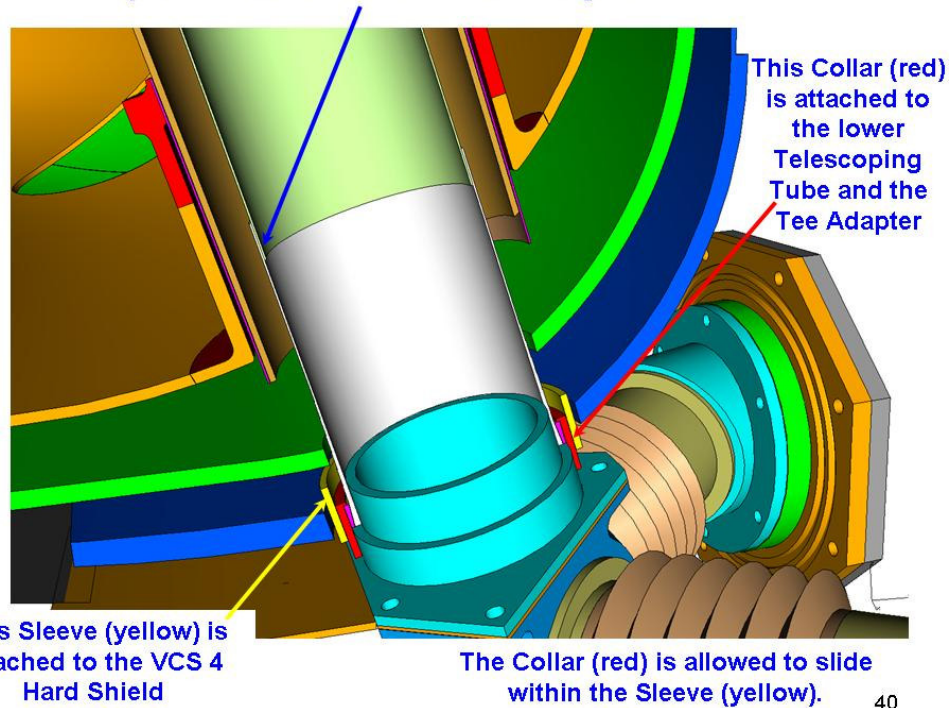
39

This joint is an interference fit that is also glued

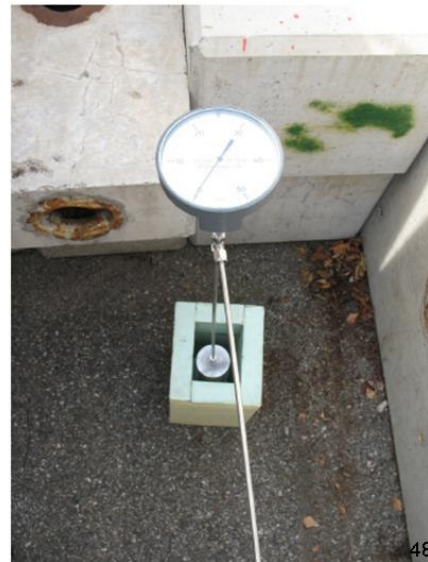
The tube was then placed in a small styrofoam dewar and connected to a 0-50 bar pressure gauge

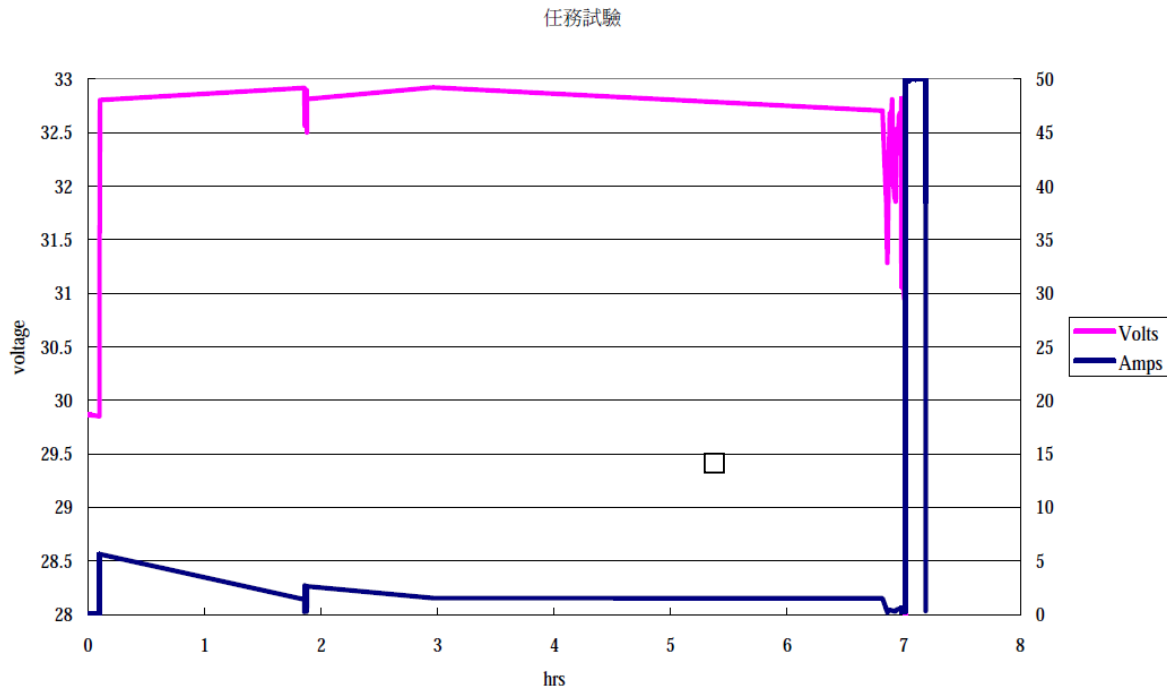
**Figure 11-2 Performance Testing of UPS.**

5. BMS charge enable signal was not implemented as an operational control. The charge enable signal from the BMS can not be used as an inhibitor or a disable for the External protection box we try to bought.
6. Parts of the top cover of UPS BOX had been melted due to high temperature (1759.0 deg. C) generated by battery short. J1 / J2 and two Test Connectors are all damaged. The equipment involved in this UPS EM charge failure event has not been tested or serviced following the event.

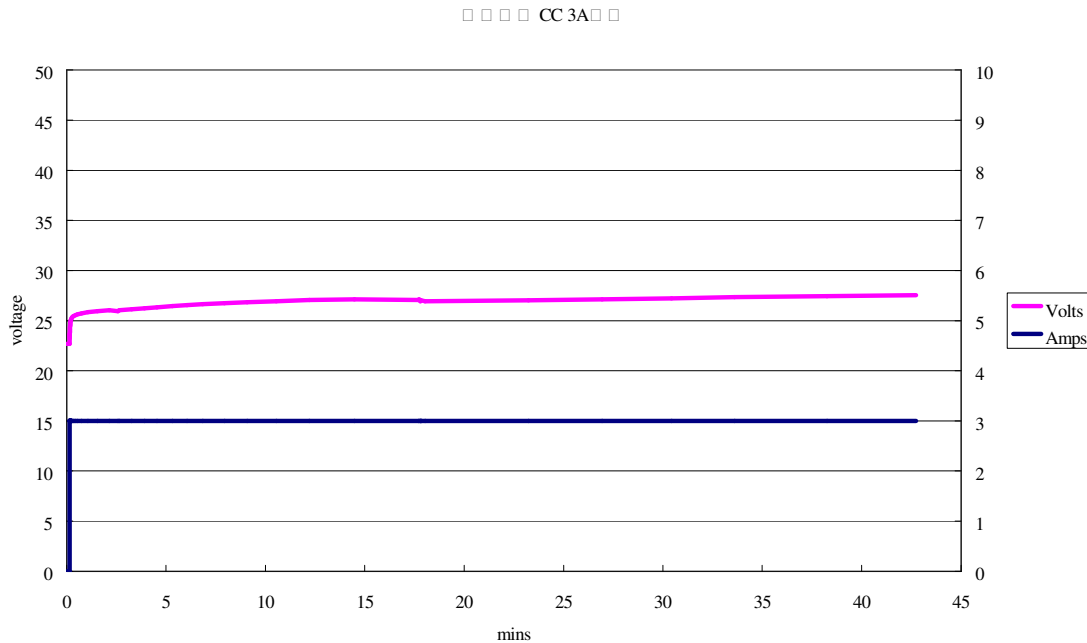
Graph 1: EDU was charged at 3 Amps for about 43 minutes.

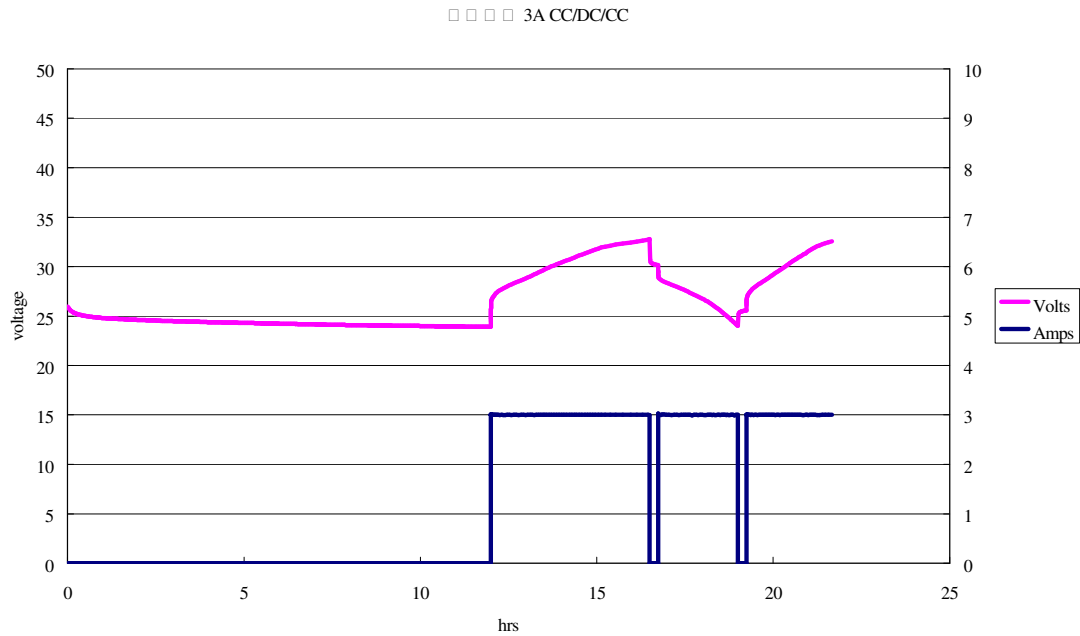
Graph 2: Open circuit for 12 hours then EM was charge/discharge/charge at 3 Amps.

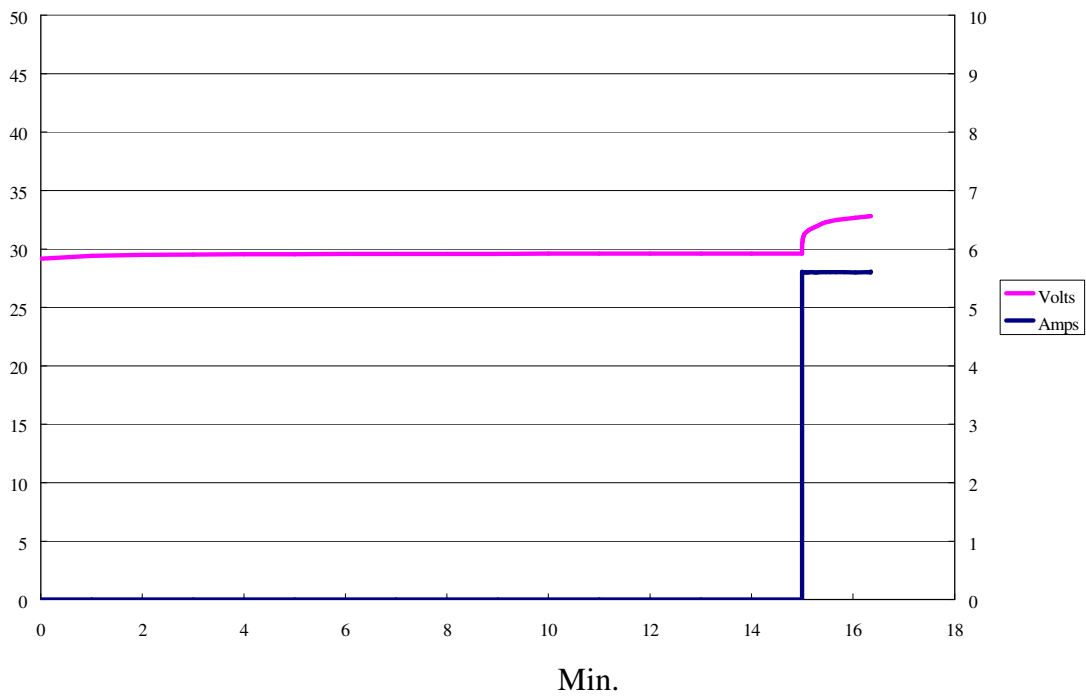
Graph 3: EM was charged at 5.6 Amps for about 1.3 minutes.

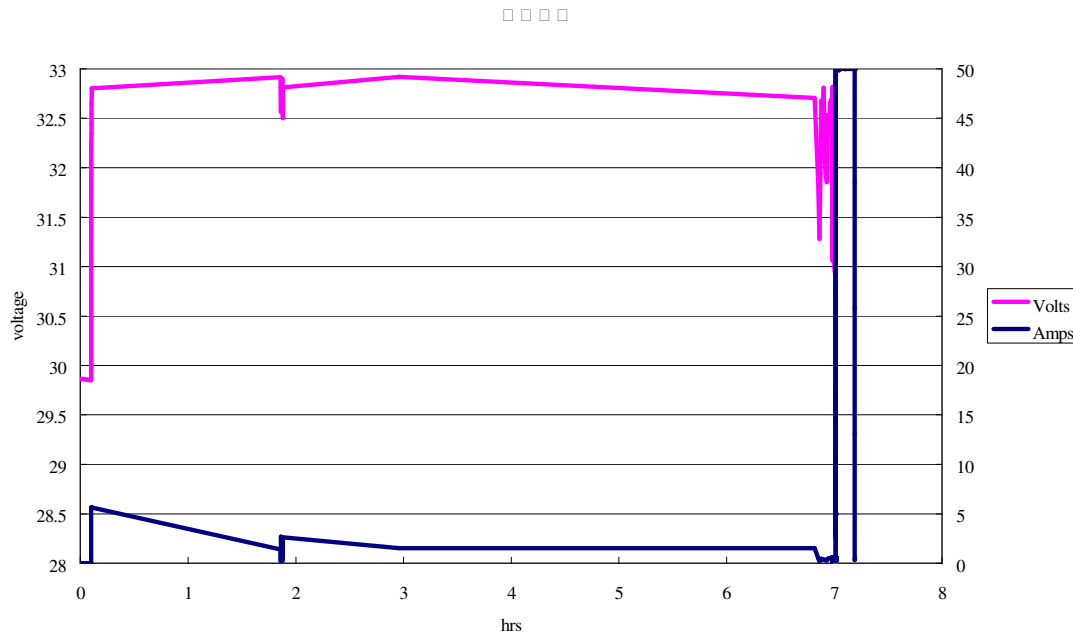
Graph 4: EM was charged at 5.6 Amps for about 0.3 minutes then EM was charged at constant voltage for about 7 hours.

7. Unfortunately, only individual cell data of Graph 4 (attached) was taken by Digital Recorder (Accuracy is  $\pm 0.01\%$  of reading) due to restriction of the Recorder memory. Voltages of Cell 1 to Cell 8 are cited in Graph 5. At 15:53:02, voltage of Cell # 7 is -0.136 V and voltages of Cell # 2/#3 are 3.801/3.450 V. The battery was not well balanced after 1<sup>st</sup> charge/discharge/charge cycle. Voltage of Cell # 7 was below 1 volt during the Constant Voltage charging period. Voltages of the health Cells #1/4/5/6/8 are above 4.67 V at 16:41:04.
8. At 23:22:58 Voltage of Cell #5 was 5.011 V. At 23:27:14 Voltage of Cell #5 was 5.850 V.
9. At 23:35:28, V5 dropped from 5.521 to -0.077 V; V3 dropped from 3.899 to 0.479 V; V7 dropped from 0.067 to -1.070 V.
10. At 23:43:08 all cells went to zero or negative volts and the temperature at cell #5 was 1759.0 deg. C.

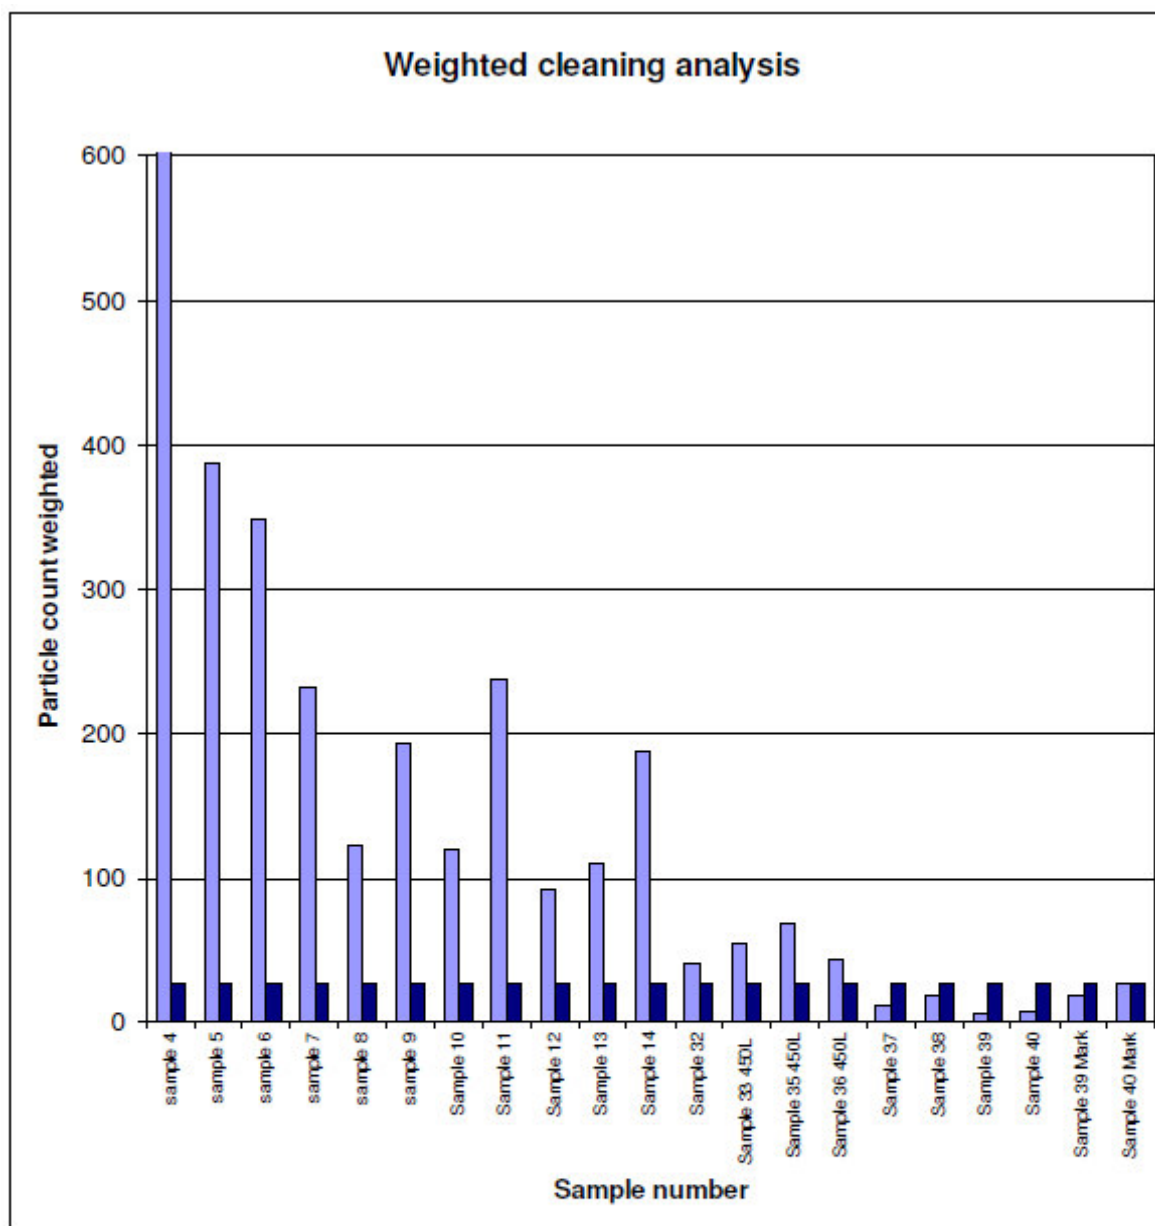
Chart of the 'weighted' particle size count against the IPA cleaning cycle number, showing the improvement in particle count as the cleaning cycles progress.

The dark blue bars show the Cleaning Specification requirement 'weighted' value of 27 units.

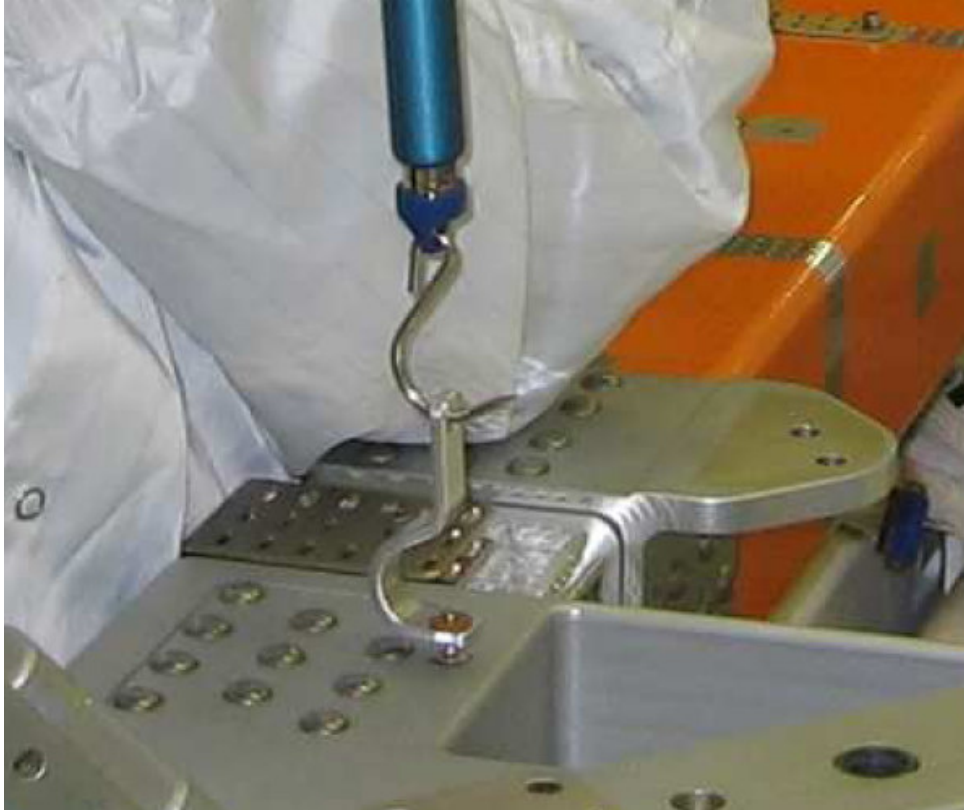
**Status:** Closed. Wednesday November 28, 2007 the pull test on all twenty installed pins were made to a minimum loading of 4 kg in tension (along the axis of the pin) and shear (a lateral force applied to the pin above the adhesion plane). All installed pins passed this test and were deemed adequately installed. This test was considered evidence that any future installation of pins that may support MLI loading per pin of 2kg or less based on a 10g acceleration condition would be enveloped and acceptable using this installation technique.

Tension Test Example

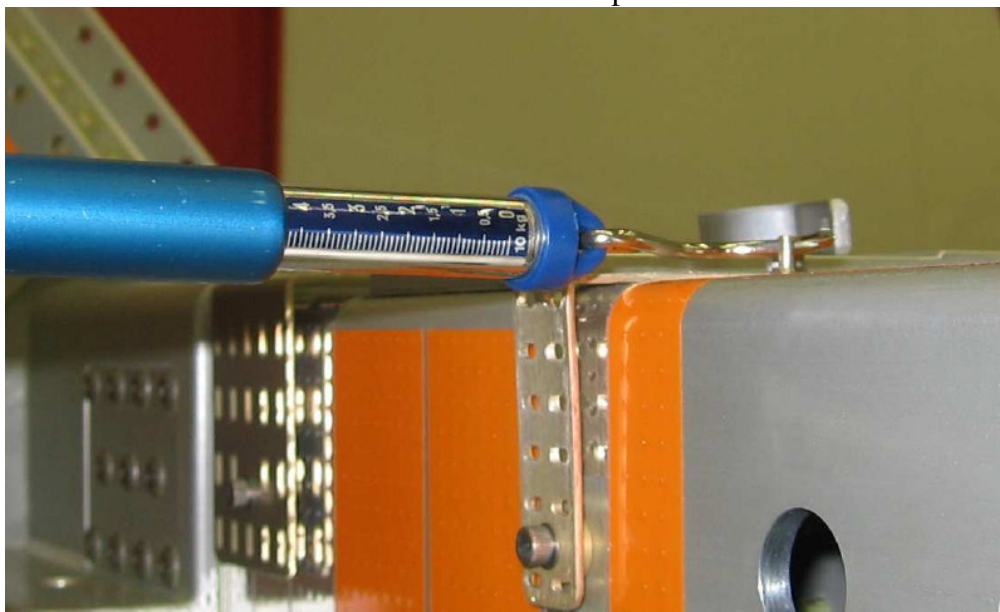
Shear Testing Example
